**Appendix A**  
**Facilities Condition Assessment**

## Facilities Condition Assessment

# Building Condition Assessment

## Building Name: Bel Air Hall

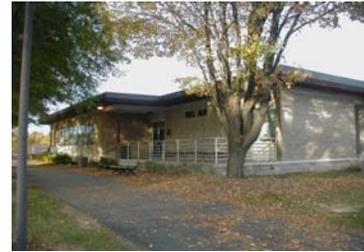
Building Component	Condition				Comments
	E	G	F	P	
<b>Building Exterior</b>					
Roofs		X			The roof was replaced in 1998 and is in excellent condition. The perimeter fascia, however, has sustained damage from insects and should be replaced.
Walls		X			
Windows			X		The single-glazed windows that face the main quad should be replaced with double-glazed, energy-efficient units.
Doors/Hardware		X			
Stairs/Ramps/Entrances			X		The concrete ramp at the main entrance should be replaced and a code-compliant handrail should be installed at the new ramp.
Painting/Caulking		X			
<b>Building Interior</b>					
Floors	X				
Walls	X				
Ceilings		X			
Doors/Hardware	X				
Stairs	X				
Painting	X				
Building Component	Condition				Comments
	C	PC	NC		
<b>ADA</b>					
Exterior Doors	X				
Interior Doors	X				
Accessible Routes (Hor)	X				
Accessible Routes (Vert)	X				
Elevators	X				
Signage	X				
Telephone			X		The public telephones in the building do not have the code required volume control and should be replaced.

Assistive Listening Device					
Drinking Fountains	X				
Toilet Rooms	X

- Replace the single-glazed windows that face the main quad with double-glazed, energy-efficient units (this work will be completed in May 2008).
- Replace the concrete ramp at the main entrance and install a code-compliant handrail.
- Replace the air-handling unit with a new energy-efficient unit.

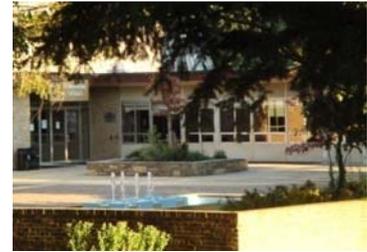
Building Component	Condition				Comments
	E	G	F	P	
<b>Building Exterior</b>					
Roofs			X		The roof (installed in 1988) is no longer under warranty and should be replaced. The perimeter fascia has sustained damage from insects and should be replaced.
Walls		X			
Windows			X		The single-glazed windows in the building should be replaced with double-glazed, energy-efficient units.
Doors/Hardware		X			
Stairs/Ramps/Entrances			X		The brick pavers and planter walls in the adjoining courtyard have deteriorated and should be repaired or replaced.
Painting/Caulking		X			
<b>Building Interior</b>					
Floors		X			
Walls		X			
Ceilings		X			
Doors/Hardware		X			
Stairs					
Painting		X			
Building Component	Condition				Comments
	C	PC	NC		
<b>ADA</b>					
Exterior Doors	X				
Interior Doors	X				
Accessible Routes (Hour)	X				
Accessible Routes (Vet)					
Elevators					
Signage	X				
Telephone			X		The public telephones in the building do not have the code required volume control and should be replaced.

Assistive Listening Device					
Drinking Fountains	X				
Toilet Rooms			X		The toilet rooms adjacent to the kitchen are not compliant and should be renovated.

- Construct a canopy over the existing loading dock for loading and unloading trucks in inclement weather.
- Renovate the toilet rooms adjacent to the kitchen to bring them into compliance with the current building code.

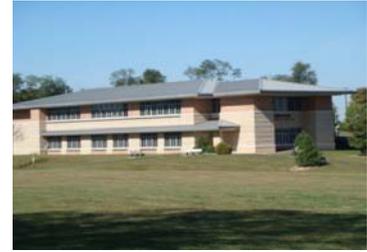
Building Component	Condition				Comments
	E	G	F	P	
<b>Building Exterior</b>					
Roofs			X		There is evidence of water damage on the existing fascia and soffit. They should be replaced and the source of the water infiltration should be investigated.
Walls		X			
Windows		X			
Doors/Hardware		X			
Stairs/Ramps/Entrances		X			
Painting/Caulking		X			
<b>Building Interior</b>					
Floors	X				The carpet and vinyl composition tile in the common areas appears to be new. The floor finishes in the remainder of the building are in good condition.
Walls	X				
Ceilings	X				The ceiling in the common areas appears to be new. The ceilings in the remainder of the building are in good condition.
Doors/Hardware		X			
Stairs			X		Chipping paint was observed at the handrails. They should be scraped and repainted.
Painting		X			
Building Component	Condition				Comments
	C	PC	NC		
<b>ADA</b>					
Exterior Doors		X			Door operators should be installed at the exterior door closest to Fallston Hall.

Interior Doors	X				
Accessible Routes (Hor)	X				
Accessible Routes (Vert)	X				
Elevators	X				
Signage	X				
Telephone					
Assistive Listening Device					
Drinking Fountains					
Toilet Rooms	X

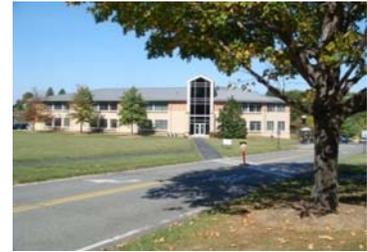
## Building Name: Fallston Hall

Building Component	Condition				Comments
	E	G	F	P	
<b>Building Exterior</b>					
Roofs			X		There is evidence of water damage on the existing fascia and soffit. They should be replaced and the source of the water infiltration should be investigated.
Walls		X			
Windows		X			
Doors/Hardware		X			
Stairs/Ramps/Entrances		X			
Painting/Caulking		X			
<b>Building Interior</b>					
Floors	X				
Walls	X				
Ceilings	X				
Doors/Hardware		X			
Stairs		X			
Painting		X			
Building Component	Condition				Comments
	C	PC	NC		
<b>ADA</b>					
Exterior Doors	X				Door operators should be installed at the exterior door closest to Edgewood Hall.
Interior Doors	X				
Accessible Routes (Hor)	X				
Accessible Routes (Vert)	X				
Elevators	X				
Signage	X				
Telephone	X				
Assistive Listening Device					
Drinking Fountains	X				
Toilet Rooms	X

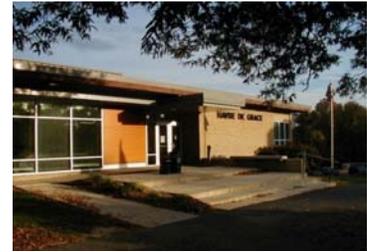
Building Component	Condition				Comments
	E	G	F	P	
<b>Building Exterior</b>					
Roofs	X				The roof was replaced in 1998 and is in excellent condition.
Walls		X			
Windows		X			
Doors/Hardware		X			
Stairs/Ramps/Entrances		X			
Painting/Caulking		X			Peeling paint was observed at the handrails around the building. The handrails should be scraped and repainted.
<b>Building Interior</b>					
Floors	X				
Walls	X				
Ceilings		X			
Doors/Hardware	X				
Stairs	X				
Painting	X				
Building Component	Condition				Comments
	C	PC	NC		
<b>ADA</b>					
Exterior Doors	X				
Interior Doors	X				
Accessible Routes (Hor)		X			A code-compliant handrail should be installed at the main entrance ramp.
Accessible Routes (Vert)	X				
Elevators	X				
Signage	X				
Telephone			X		The public telephones in the building do not have the code required volume control and should be replaced.
Assistive Listening Device					
Drinking Fountains	X

Toilet Rooms	X

- Install a code-compliant handrail at the main entrance ramp.

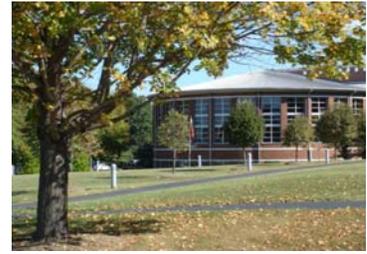
Building Component	Condition				Comments
	E	G	F	P	
<b>Building Exterior</b>					
Roofs		X			
Walls		X			
Windows		X			
Doors/Hardware		X			
Stairs/Ramps/Entrances		X			Several brick pavers have become loose and should be reset.
Painting/Caulking		X			
<b>Building Interior</b>					
Floors	X				
Walls	X				
Ceilings		X			
Doors/Hardware		X			
Stairs		X			
Painting		X			
Building Component	Condition				Comments
	C	PC	NC		
<b>ADA</b>					
Exterior Doors	X				
Interior Doors	X				
Accessible Routes (Hor)	X				
Accessible Routes (Vert)	X				
Elevators	X				
Signage	X				
Telephone					
Assistive Listening Device					
Drinking Fountains	X				
Toilet Rooms	X

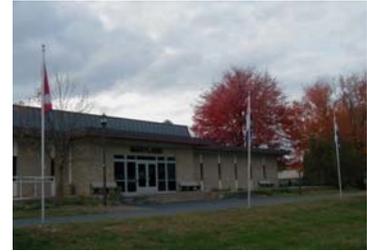
Building Component	Condition				Comments
	E	G	F	P	
<b>Building Exterior</b>					
Roofs		X			The roof was replaced in 1993 and is in excellent condition. The perimeter fascia, however, has sustained damage from insects and should be replaced.
Walls	X				
Windows			X		The single-glazed windows in the building should be replaced with double-glazed, energy-efficient units.
Doors/Hardware		X			
Stairs/Ramps/Entrances			X		The stone walls at the patio on the east side of the building have deteriorated and should be repaired or replaced.
Painting/Caulking			X		The caulk between the brick walls and stone base is beginning to crack and should be replaced.
<b>Building Interior</b>					
Floors	X				
Walls	X				
Ceilings		X			
Doors/Hardware	X				
Stairs					
Painting	X				
Building Component	Condition				Comments
	C	PC	NC		
<b>ADA</b>					
Exterior Doors	X				
Interior Doors	X				
Accessible Routes (Hor)		X			The concrete ramp at the main entrance does not have the code required landing and should be modified.

Accessible Routes (Vert)					
Elevators					
Signage	X				
Telephone			X		The public telephones in the building do not have the code required volume control and should be replaced.
Assistive Listening Device					
Drinking Fountains	X				
Toilet Rooms	X

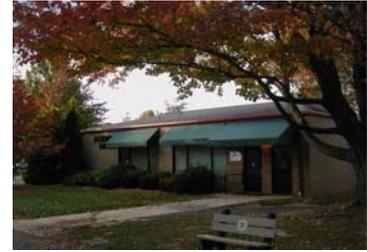
Building Component	Condition				Comments
	E	G	F	P	
<b>Building Exterior</b>					
Roofs	X				
Walls	X				
Windows	X				
Doors/Hardware		X			
Stairs/Ramps/Entrances		X			
Painting/Caulking		X			
<b>Building Interior</b>					
Floors		X			Some of the sheet vinyl in the building is beginning to peel and should be replaced.
Walls	X				
Ceilings	X				
Doors/Hardware	X				
Stairs					
Painting	X				
Building Component	Condition				Comments
	C	PC	NC		
<b>ADA</b>					
Exterior Doors	X				
Interior Doors	X				
Accessible Routes (Hor)	X				
Accessible Routes (Vert)					
Elevators					
Signage	X				
Telephone					
Assistive Listening Device					
Drinking Fountains	X				
Toilet Rooms	X

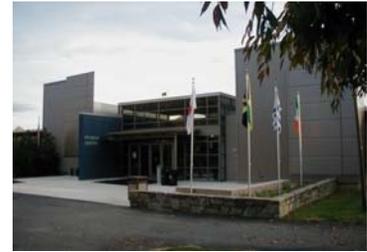
Building Component	Condition				Comments
	E	G	F	P	
<b>Building Exterior</b>					
Roofs		X			The roof (installed in 1990) is no longer under warranty and should be replaced.
Walls		X			Minor efflorescence was observed on the brick walls. The walls should be cleaned and monitored to ensure that the efflorescence is not the result of water infiltration.
Windows			X		The single-glazed windows in the building should be replaced with double-glazed, energy-efficient units.
Doors/Hardware		X			
Stairs/Ramps/Entrances		X			
Painting/Caulking		X			Peeling paint was observed at several locations around the building. These areas should be scraped and repainted.
<b>Building Interior</b>					
Floors		X			Some of the sheet vinyl in the building is beginning to deteriorate and should be replaced.
Walls	X				
Ceilings		X			
Doors/Hardware	X				
Stairs	X				
Painting	X				
Building Component	Condition				Comments
	C	PC	NC

<b>ADA</b>					
Exterior Doors	X				
Interior Doors	X				
Accessible Routes (Hor)	X				
Accessible Routes (Vert)	X				
Elevators	X				
Signage	X				
Telephone			X		The public telephones in the building do not have the code required volume control and should be replaced.
Assistive Listening Device					
Drinking Fountains	X				
Toilet Rooms	X
